**SITE CHARACTERISATION OF THE WHATAROA VALLEY
FOR THE DEEP ALPINE FAULT DRILLING PROJECT STAGE 2 (DFDP-2),
WEST COAST, NEW ZEALAND.**

Degree of Master of Science in Engineering Geology

University of Canterbury

Andrew Paul Klahn

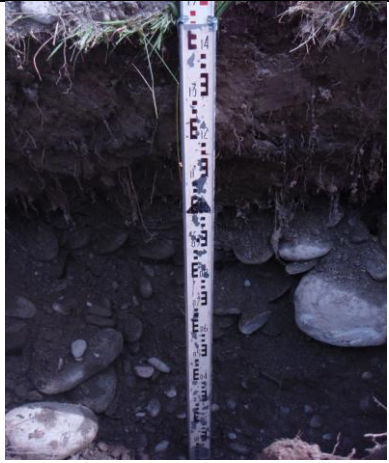
FROM (m): <u>0</u> TO (m): <u>0.6</u>				Photo

TERTIARY COMPONENT		SECONDARY COMPONENT			PRIMARY COMPONENT
					Sand
MODIFIER	MINOR COMPONENT				PLASTICITY
					non
PARTICLE SIZE		MODIFIER	PARTICLE SIZE		
Fine sand					
PARTICLE SHAPE		MODIFIER	PARTICLE SHAPE		
COLOUR 1		COLOUR 2			MOISTURE
Brownish		Grey		moist	
CONSISTENCY / DENSITY		MODIFIER	CONSISTENCY / DENSITY		
loose					
ADDITIONAL COMMENTS					
Rootlets to 700mm					
Topsoil grading to sand over 200mm

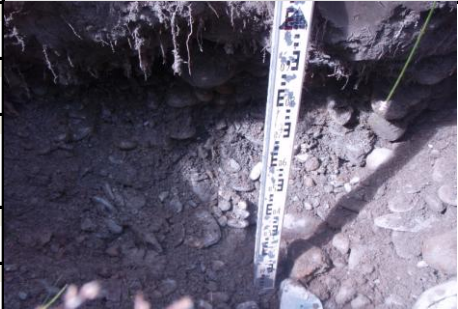
FROM (m): <u>0.6</u> TO (m): <u>1.5</u>				Photo

TERTIARY COMPONENT		SECONDARY COMPONENT			PRIMARY COMPONENT
		Sandy			Gravel
MODIFIER	MINOR COMPONENT				PLASTICITY
with	Cobbles & boulders				non
PARTICLE SIZE		MODIFIER	PARTICLE SIZE		
Medium sand		to	Coarse sand		
Fine gravel		to	Coarse gravel		
PARTICLE SHAPE		MODIFIER	PARTICLE SHAPE		
Sub-angular		to	Sub-rounded		
COLOUR 1		COLOUR 2		MOISTURE	
Grey				moist	
CONSISTENCY / DENSITY		MODIFIER	CONSISTENCY / DENSITY		
loose					
ADDITIONAL COMMENTS					
Boulders to 400mm in size

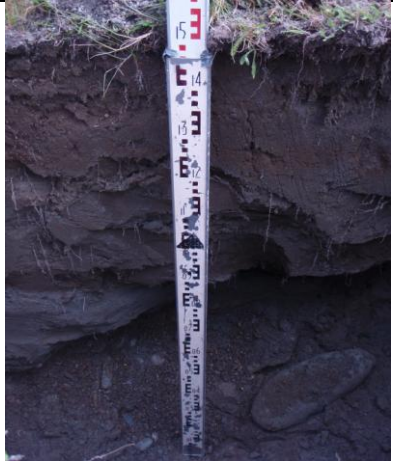
FROM (m): <u>0</u> TO (m): <u>0.8</u>				Photo

TERTIARY COMPONENT		SECONDARY COMPONENT			PRIMARY COMPONENT
					Sand
MODIFIER	MINOR COMPONENT				PLASTICITY
					non
PARTICLE SIZE		MODIFIER	PARTICLE SIZE		
Fine sand		to	Medium sand		
PARTICLE SHAPE		MODIFIER	PARTICLE SHAPE		
COLOUR 1		COLOUR 2			MOISTURE
Brownish		Grey		moist	
CONSISTENCY / DENSITY		MODIFIER	CONSISTENCY / DENSITY		
loose					
ADDITIONAL COMMENTS					
Rootlets to 1m					
Little to no topsoil

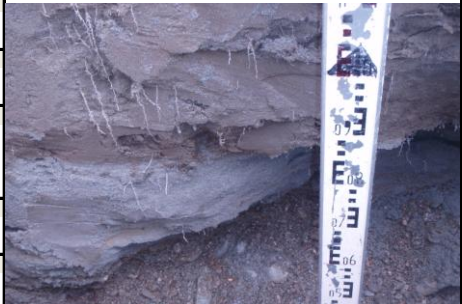
FROM (m): <u>0.8</u> TO (m): <u>1.4</u>				Photo

TERTIARY COMPONENT		SECONDARY COMPONENT			PRIMARY COMPONENT
					Sand
MODIFIER	MINOR COMPONENT				PLASTICITY
					non
PARTICLE SIZE		MODIFIER	PARTICLE SIZE		
Fine sand		to	Medium sand		
PARTICLE SHAPE		MODIFIER	PARTICLE SHAPE		
COLOUR 1		COLOUR 2			MOISTURE
Grey				moist	
CONSISTENCY / DENSITY		MODIFIER	CONSISTENCY / DENSITY		
loose					
ADDITIONAL COMMENTS

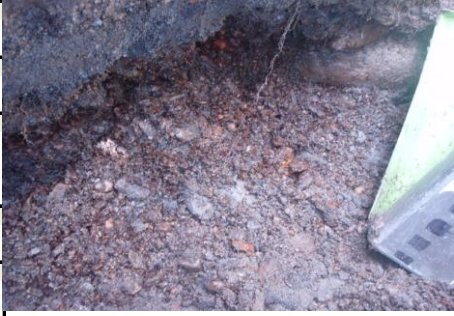
FROM (m): <u>1.4</u> TO (m): <u>1.5</u>				Photo

TERTIARY COMPONENT		SECONDARY COMPONENT			PRIMARY COMPONENT
		Sandy			Gravel
MODIFIER	MINOR COMPONENT				PLASTICITY
with	Cobbles & boulders				non
PARTICLE SIZE		MODIFIER	PARTICLE SIZE		
Coarse sand Fine gravel		to	Coarse gravel		
PARTICLE SHAPE		MODIFIER	PARTICLE SHAPE		
Sub-rounded		to	Angular		
COLOUR 1		COLOUR 2			MOISTURE
Brownish		Grey		moist	
CONSISTENCY / DENSITY		MODIFIER	CONSISTENCY / DENSITY		
loose					
ADDITIONAL COMMENTS					
1420 gravel?, iron staining, high content of quartz clasts.

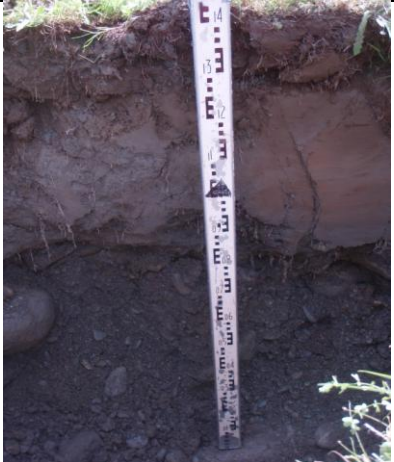
FROM (m): <u>0</u> TO (m): <u>0.8</u>				Photo

TERTIARY COMPONENT		SECONDARY COMPONENT			PRIMARY COMPONENT
					Sand
MODIFIER	MINOR COMPONENT				PLASTICITY
					non
PARTICLE SIZE		MODIFIER	PARTICLE SIZE		
Fine sand					
PARTICLE SHAPE		MODIFIER	PARTICLE SHAPE		
COLOUR 1		COLOUR 2			MOISTURE
Grey with some		greyish brown		moist	
CONSISTENCY / DENSITY		MODIFIER	CONSISTENCY / DENSITY		
loose					
ADDITIONAL COMMENTS					
Topsoil grading to sand over 200mm

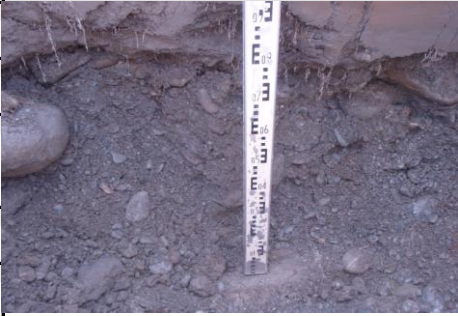
FROM (m): <u>0.8</u> TO (m): <u>1.5</u>				Photo

TERTIARY COMPONENT		SECONDARY COMPONENT			PRIMARY COMPONENT
		Sandy			Gravel
MODIFIER	MINOR COMPONENT				PLASTICITY
with	Cobbles & boulders				non
PARTICLE SIZE		MODIFIER	PARTICLE SIZE		
Medium sand		to	Coarse sand		
Fine gravel		to	Coarse gravel		
PARTICLE SHAPE		MODIFIER	PARTICLE SHAPE		
Sub-angular		to	Sub-rounded		
COLOUR 1		COLOUR 2		MOISTURE	
Grey				moist	
CONSISTENCY / DENSITY		MODIFIER	CONSISTENCY / DENSITY		
loose					
ADDITIONAL COMMENTS					
Boulders to 800mm in size

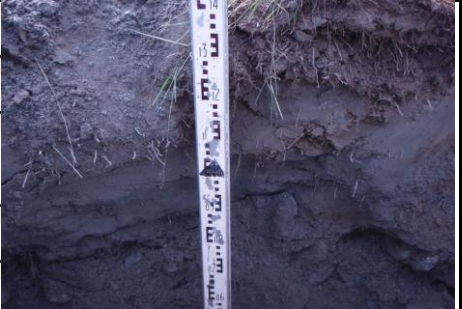
FROM (m): <u>0</u> TO (m): <u>0.8</u>				Photo

<small>TERTIARY COMPONENT</small>		<small>SECONDARY COMPONENT</small>			<small>PRIMARY COMPONENT</small>
					Sand
<small>MODIFIER</small>	<small>MINOR COMPONENT</small>				<small>PLASTICITY</small>
					non
<small>PARTICLE SIZE</small>		<small>MODIFIER</small>	<small>PARTICLE SIZE</small>		
Fine sand					
<small>PARTICLE SHAPE</small>		<small>MODIFIER</small>	<small>PARTICLE SHAPE</small>		
<small>COLOUR 1</small>		<small>COLOUR 2</small>			<small>MOISTURE</small>
Grey with some		greyish brown		moist	
<small>CONSISTENCY / DENSITY</small>		<small>MODIFIER</small>	<small>CONSISTENCY / DENSITY</small>		
loose					
<small>ADDITIONAL COMMENTS</small>					
Rootlets to 600mm					
Topsoil grading to sand over 200mm

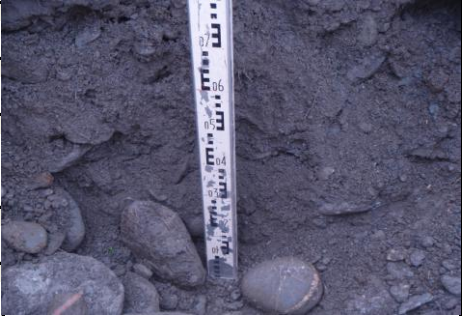
FROM (m): <u>0.8</u> TO (m): <u>1.5</u>				Photo

<small>TERTIARY COMPONENT</small>		<small>SECONDARY COMPONENT</small>			<small>PRIMARY COMPONENT</small>
		Sandy			Gravel
<small>MODIFIER</small>	<small>MINOR COMPONENT</small>				<small>PLASTICITY</small>
with	Cobbles & boulders				non
<small>PARTICLE SIZE</small>		<small>MODIFIER</small>	<small>PARTICLE SIZE</small>		
Medium sand		to	Coarse sand		
Fine gravel		to	Coarse gravel		
<small>PARTICLE SHAPE</small>		<small>MODIFIER</small>	<small>PARTICLE SHAPE</small>		
Sub-angular		to	Sub-rounded		
<small>COLOUR 1</small>		<small>COLOUR 2</small>		<small>MOISTURE</small>	
Grey				moist	
<small>CONSISTENCY / DENSITY</small>		<small>MODIFIER</small>	<small>CONSISTENCY / DENSITY</small>		
loose					
<small>ADDITIONAL COMMENTS</small>					
Boulders to 800mm in size

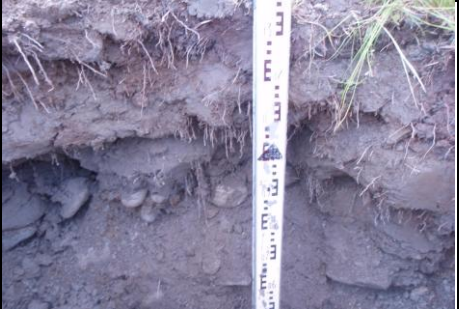
FROM (m): <u>0</u> TO (m): <u>0.6</u>				Photo

TERTIARY COMPONENT		SECONDARY COMPONENT			PRIMARY COMPONENT
					Sand
MODIFIER	MINOR COMPONENT				PLASTICITY
					non
PARTICLE SIZE		MODIFIER	PARTICLE SIZE		
Fine sand					
PARTICLE SHAPE		MODIFIER	PARTICLE SHAPE		
COLOUR 1		COLOUR 2			MOISTURE
Grey with some		greyish brown		moist	
CONSISTENCY / DENSITY		MODIFIER	CONSISTENCY / DENSITY		
loose					
ADDITIONAL COMMENTS					
Rootlets to 700mm					
Topsoil grading to sand over 200mm

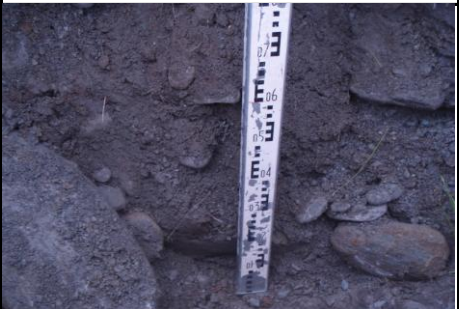
FROM (m): <u>0.6</u> TO (m): <u>1.4</u>				Photo

TERTIARY COMPONENT		SECONDARY COMPONENT			PRIMARY COMPONENT
		Sandy			Gravel
MODIFIER	MINOR COMPONENT				PLASTICITY
with	Cobbles & boulders				non
PARTICLE SIZE		MODIFIER	PARTICLE SIZE		
Medium sand		to	Coarse sand		
Fine gravel		to	Coarse gravel		
PARTICLE SHAPE		MODIFIER	PARTICLE SHAPE		
Sub-angular		to	Sub-rounded		
COLOUR 1		COLOUR 2		MOISTURE	
Grey				moist	
CONSISTENCY / DENSITY		MODIFIER	CONSISTENCY / DENSITY		
loose					
ADDITIONAL COMMENTS					
Boulders to 700mm in size

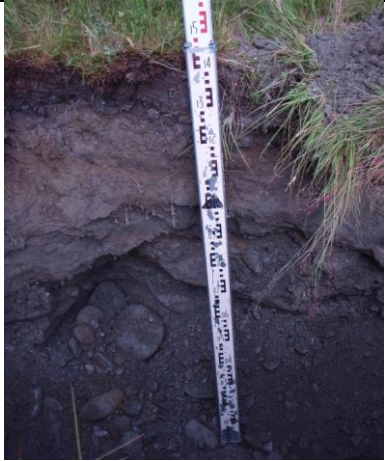
FROM (m): <u>0</u> TO (m): <u>0.6</u>				Photo

TERTIARY COMPONENT		SECONDARY COMPONENT			PRIMARY COMPONENT
					Sand
MODIFIER	MINOR COMPONENT				PLASTICITY
					non
PARTICLE SIZE		MODIFIER	PARTICLE SIZE		
Fine sand					
PARTICLE SHAPE		MODIFIER	PARTICLE SHAPE		
COLOUR 1		COLOUR 2			MOISTURE
Grey with some		greyish brown		moist	
CONSISTENCY / DENSITY		MODIFIER	CONSISTENCY / DENSITY		
loose					
ADDITIONAL COMMENTS					
Topsoil grading to sand over 200mm

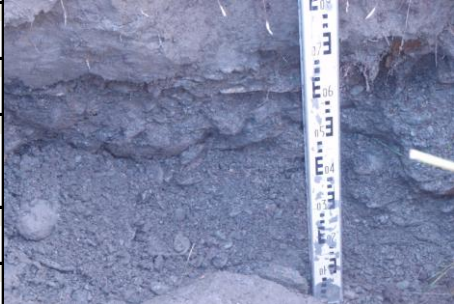
FROM (m): <u>0.5</u> TO (m): <u>1.2</u>				Photo

TERTIARY COMPONENT		SECONDARY COMPONENT			PRIMARY COMPONENT
		Sandy			Gravel
MODIFIER	MINOR COMPONENT				PLASTICITY
with	Cobbles & boulders				non
PARTICLE SIZE		MODIFIER	PARTICLE SIZE		
Medium sand		to	Coarse sand		
Fine gravel		to	Coarse gravel		
PARTICLE SHAPE		MODIFIER	PARTICLE SHAPE		
Sub-angular		to	Sub-rounded		
COLOUR 1		COLOUR 2		MOISTURE	
Grey				moist	
CONSISTENCY / DENSITY		MODIFIER	CONSISTENCY / DENSITY		
loose					
ADDITIONAL COMMENTS					
Boulders to 800mm in size

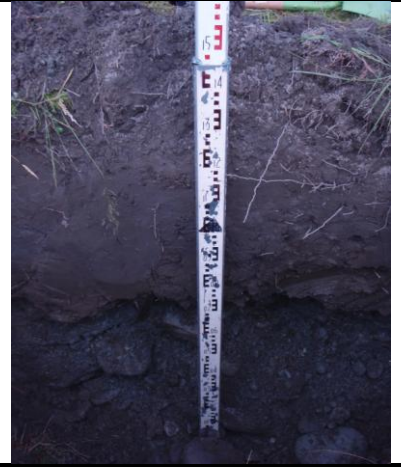
FROM (m): <u>0</u> TO (m): <u>0.9</u>				Photo	
TERTIARY COMPONENT		SECONDARY COMPONENT		PRIMARY COMPONENT	
				Sand	
MODIFIER	MINOR COMPONENT			PLASTICITY	
				non	
PARTICLE SIZE		MODIFIER		PARTICLE SIZE	
Fine sand					
PARTICLE SHAPE		MODIFIER		PARTICLE SHAPE	
COLOUR 1		COLOUR 2		MOISTURE	
Brownish		Grey		moist	
CONSISTENCY / DENSITY		MODIFIER		CONSISTENCY / DENSITY	
loose					
ADDITIONAL COMMENTS

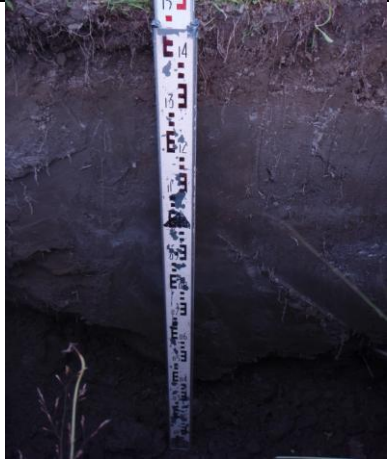
FROM (m): <u>0</u> TO (m): <u>1.2</u>				Photo

<small>TERTIARY COMPONENT</small>		<small>SECONDARY COMPONENT</small>			<small>PRIMARY COMPONENT</small>
					Sand
<small>MODIFIER</small>	<small>MINOR COMPONENT</small>				<small>PLASTICITY</small>
					non
<small>PARTICLE SIZE</small>		<small>MODIFIER</small>	<small>PARTICLE SIZE</small>		
Fine sand		to	medium sand		
<small>PARTICLE SHAPE</small>		<small>MODIFIER</small>	<small>PARTICLE SHAPE</small>		
<small>COLOUR 1</small>		<small>COLOUR 2</small>			<small>MOISTURE</small>
Brownish		Grey		moist	
<small>CONSISTENCY / DENSITY</small>		<small>MODIFIER</small>	<small>CONSISTENCY / DENSITY</small>		
loose					
<small>ADDITIONAL COMMENTS</small>					
Topsoil grades over 200mm

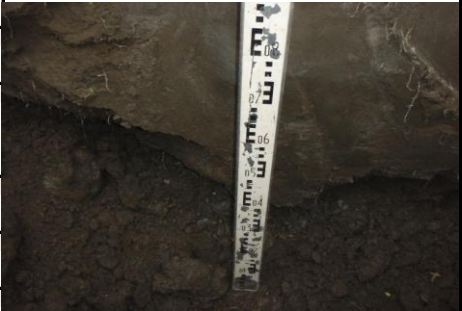
FROM (m): <u>1.2</u> TO (m): <u>1.5</u>				Photo

<small>TERTIARY COMPONENT</small>		<small>SECONDARY COMPONENT</small>			<small>PRIMARY COMPONENT</small>
		Sandy			Gravel
<small>MODIFIER</small>	<small>MINOR COMPONENT</small>				<small>PLASTICITY</small>
with	Cobbles & boulders				non
<small>PARTICLE SIZE</small>		<small>MODIFIER</small>	<small>PARTICLE SIZE</small>		
Medium sand		to	Coarse sand		
Fine gravel		to	Coarse gravel		
<small>PARTICLE SHAPE</small>		<small>MODIFIER</small>	<small>PARTICLE SHAPE</small>		
Sub-angular		to	Sub-rounded		
<small>COLOUR 1</small>		<small>COLOUR 2</small>		<small>MOISTURE</small>	
Grey				moist	
<small>CONSISTENCY / DENSITY</small>		<small>MODIFIER</small>	<small>CONSISTENCY / DENSITY</small>		
loose					
<small>ADDITIONAL COMMENTS</small>					
Boulders to 400mm in size

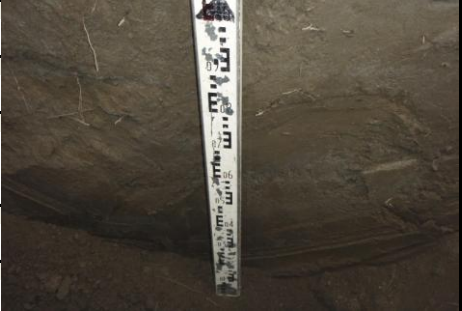
FROM (m): <u>0</u> TO (m): <u>1.6</u>				Photo

TERTIARY COMPONENT		SECONDARY COMPONENT			PRIMARY COMPONENT
					Sand
MODIFIER	MINOR COMPONENT				PLASTICITY
					non
PARTICLE SIZE		MODIFIER	PARTICLE SIZE		
Fine sand		to	medium sand		
PARTICLE SHAPE		MODIFIER	PARTICLE SHAPE		
COLOUR 1		COLOUR 2			MOISTURE
Brownish		Grey		moist	
CONSISTENCY / DENSITY		MODIFIER	CONSISTENCY / DENSITY		
loose					
ADDITIONAL COMMENTS					
Topsoil grades over 200mm

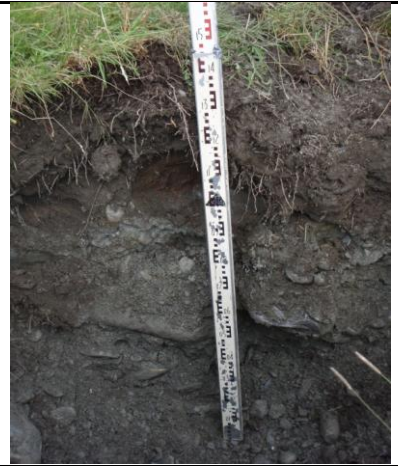
FROM (m): <u>0.2</u> TO (m): <u>1.5</u>				Photo	
TERTIARY COMPONENT		SECONDARY COMPONENT		PRIMARY COMPONENT	
		<u>Sandy</u>		<u>Gravel</u>	
MODIFIER	MINOR COMPONENT			PLASTICITY	
<u>with</u>	<u>Cobbles & boulders</u>			<u>non</u>	
PARTICLE SIZE		MODIFIER		PARTICLE SIZE	
<u>Medium sand</u>		<u>to</u>		<u>Coarse sand</u>	
<u>Fine gravel</u>		<u>to</u>		<u>Coarse gravel</u>	
PARTICLE SHAPE		MODIFIER		PARTICLE SHAPE	
<u>Sub-angular</u>		<u>to</u>		<u>Sub-rounded</u>	
COLOUR 1	COLOUR 2			MOISTURE	
<u>Grey</u>				<u>moist</u>	
CONSISTENCY / DENSITY			MODIFIER		CONSISTENCY / DENSITY
<u>loose</u>					
ADDITIONAL COMMENTS					
<u>Rootlets to 600mm Boulders to 600mm in size</u>					
<u>Topsoil grading to gravel over 300mm</u>

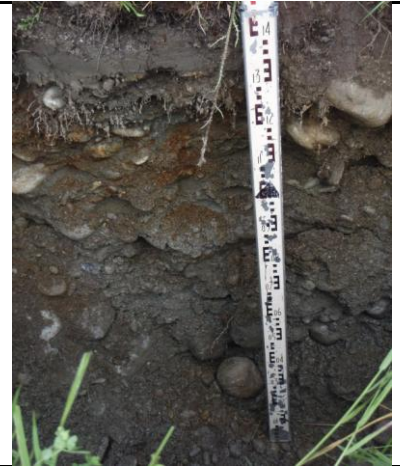
FROM (m): <u>0</u> TO (m): <u>0.2</u>				Photo	
TERTIARY COMPONENT		SECONDARY COMPONENT		PRIMARY COMPONENT	
				Sand	
MODIFIER	MINOR COMPONENT			PLASTICITY	
				non	
PARTICLE SIZE		MODIFIER		PARTICLE SIZE	
fine sand					
PARTICLE SHAPE		MODIFIER		PARTICLE SHAPE	
COLOUR 1		COLOUR 2		MOISTURE	
grey				moist	
CONSISTENCY / DENSITY		MODIFIER		CONSISTENCY / DENSITY	
loose					
ADDITIONAL COMMENTS

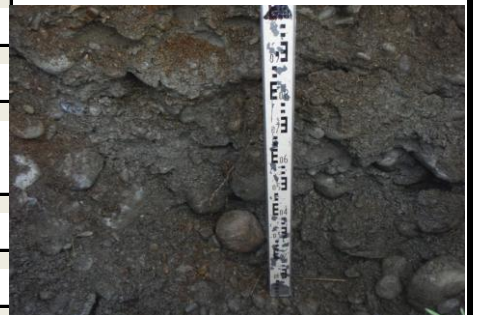
FROM (m): <u>0.2</u> TO (m): <u>1.5</u>				Photo	
TERTIARY COMPONENT		SECONDARY COMPONENT		PRIMARY COMPONENT	
		Sandy		Gravel	
MODIFIER	MINOR COMPONENT			PLASTICITY	
with	Cobbles & boulders			non	
PARTICLE SIZE		MODIFIER		PARTICLE SIZE	
Medium sand		to		Coarse sand	
Fine gravel		to		Coarse gravel	
PARTICLE SHAPE		MODIFIER		PARTICLE SHAPE	
Sub-angular		to		Sub-rounded	
COLOUR 1		COLOUR 2		MOISTURE	
Grey				moist	
CONSISTENCY / DENSITY		MODIFIER		CONSISTENCY / DENSITY	
loose					
ADDITIONAL COMMENTS					
Small lense of brown coarse sand at the top of unit, buried soil horizon?

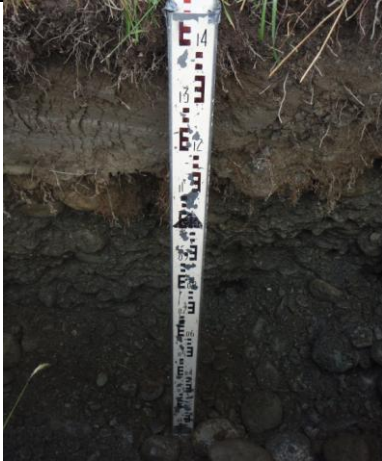
FROM (m): <u>0</u> TO (m): <u>0.4</u>				Photo

TERTIARY COMPONENT		SECONDARY COMPONENT			PRIMARY COMPONENT
					Sand
MODIFIER	MINOR COMPONENT				PLASTICITY
					non
PARTICLE SIZE		MODIFIER	PARTICLE SIZE		
Fine sand					
PARTICLE SHAPE		MODIFIER	PARTICLE SHAPE		
COLOUR 1		COLOUR 2			MOISTURE
Brownish		Grey		moist	
CONSISTENCY / DENSITY		MODIFIER	CONSISTENCY / DENSITY		
loose					
ADDITIONAL COMMENTS

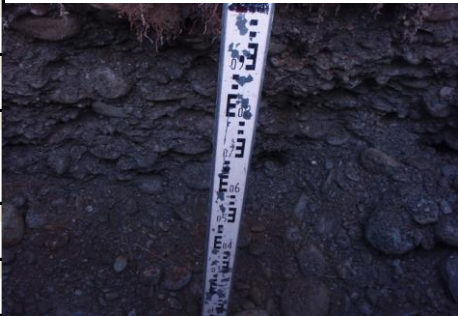
FROM (m): <u>0.4</u> TO (m): <u>1.5</u>				Photo

TERTIARY COMPONENT		SECONDARY COMPONENT			PRIMARY COMPONENT
		Sandy			Gravel
MODIFIER	MINOR COMPONENT				PLASTICITY
with	Cobbles & boulders				non
PARTICLE SIZE		MODIFIER	PARTICLE SIZE		
Medium sand		to	Coarse sand		
Fine gravel		to	Coarse gravel		
PARTICLE SHAPE		MODIFIER	PARTICLE SHAPE		
Sub-angular		to	Sub-rounded		
COLOUR 1		COLOUR 2		MOISTURE	
Grey				moist	
CONSISTENCY / DENSITY		MODIFIER	CONSISTENCY / DENSITY		
loose					
ADDITIONAL COMMENTS					
Boulders to 300mm in size
